# UNDERWATER BRIDGE INSPECTION REPORT

STRUCTURE NO. 36508

CSAH NO. 6

BRANCH OF THE CALDWELL CREEK

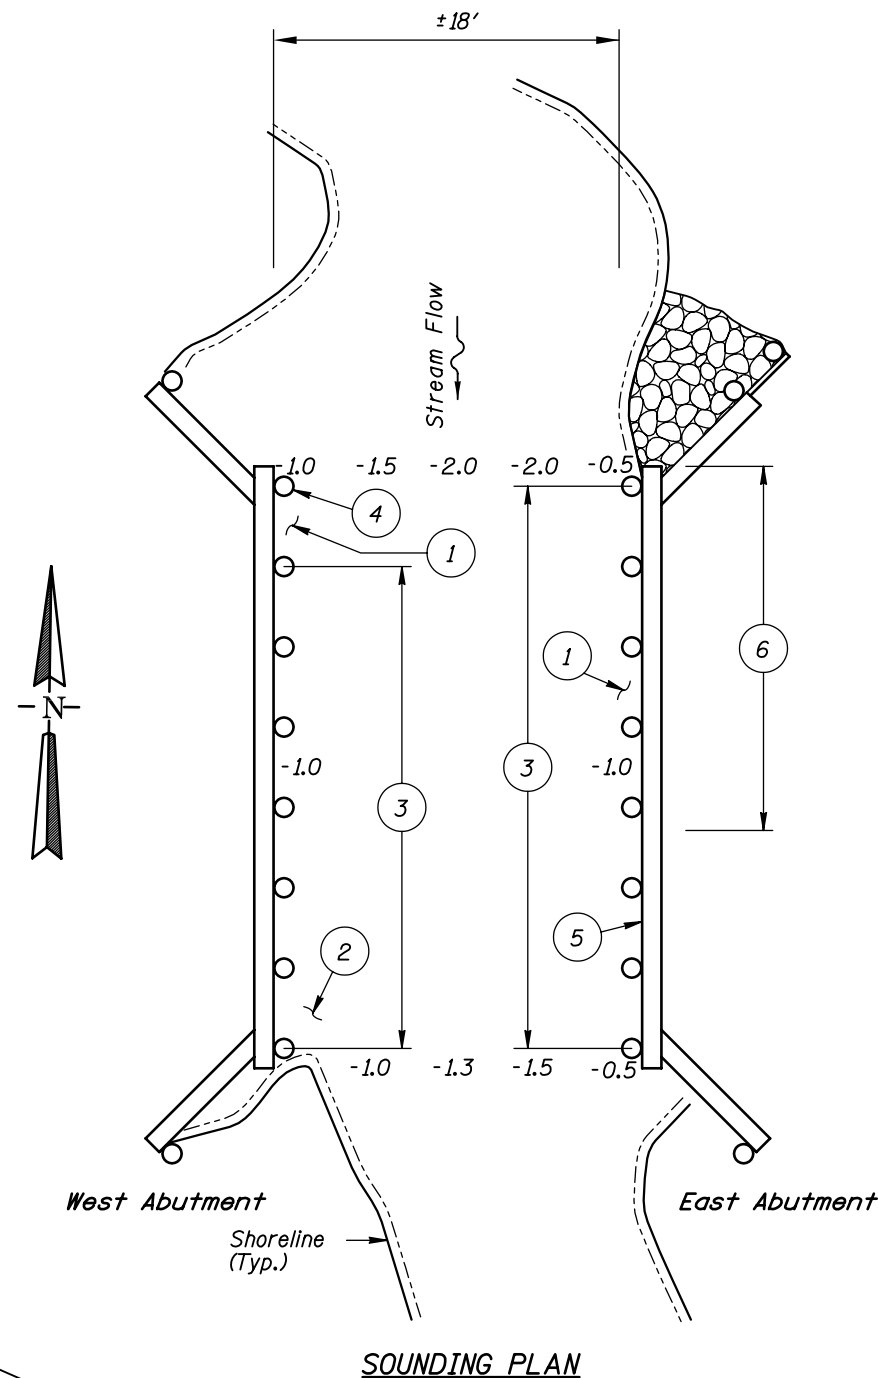
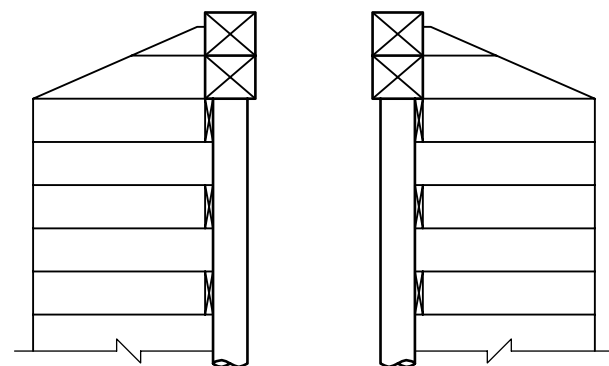
**INSPECTION AND SOUNDING PLAN**

- 1 The channel bottom consisted of 1-foot-diameter cobbles and riprap with no probe rod penetration.
- 2 The channel bottom consisted of silt and scattered riprap with up to 1 foot of probe rod penetration.
- 3 The timber piles were in good sound condition with occasional checking up to 1/8 inch wide.
- 4 The timber pile exhibited up to 1.5-inch-wide cracking with decay, in several locations, through to the middle of the pile.
- 5 The backwall exhibited 1/4-inch-wide gaps between the planks with minor planking movement detected, but no loss of fill.
- 6 A 1/4 inch wide split in the wall planking was observed 2 feet above the waterline and extended between the upstream pile of the East Abutment and the 5th pile in from the upstream fascia.

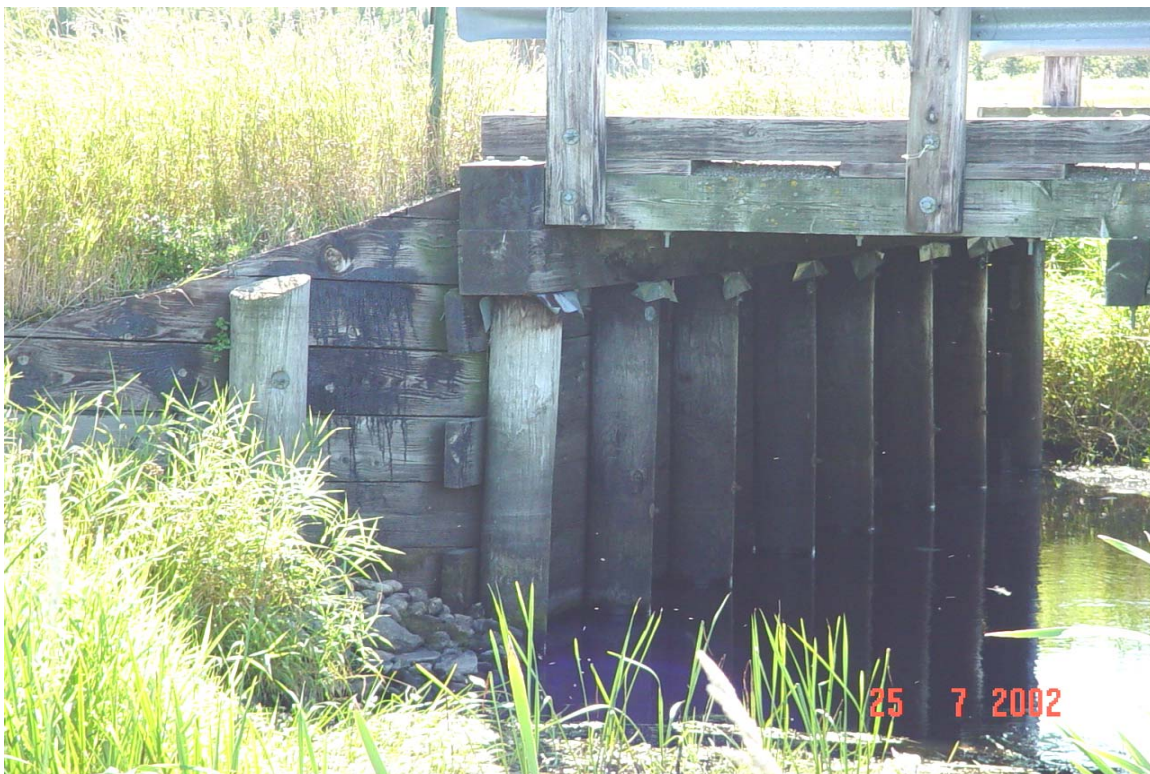
Photograph 2. View of East Abutment, Looking Southeast.

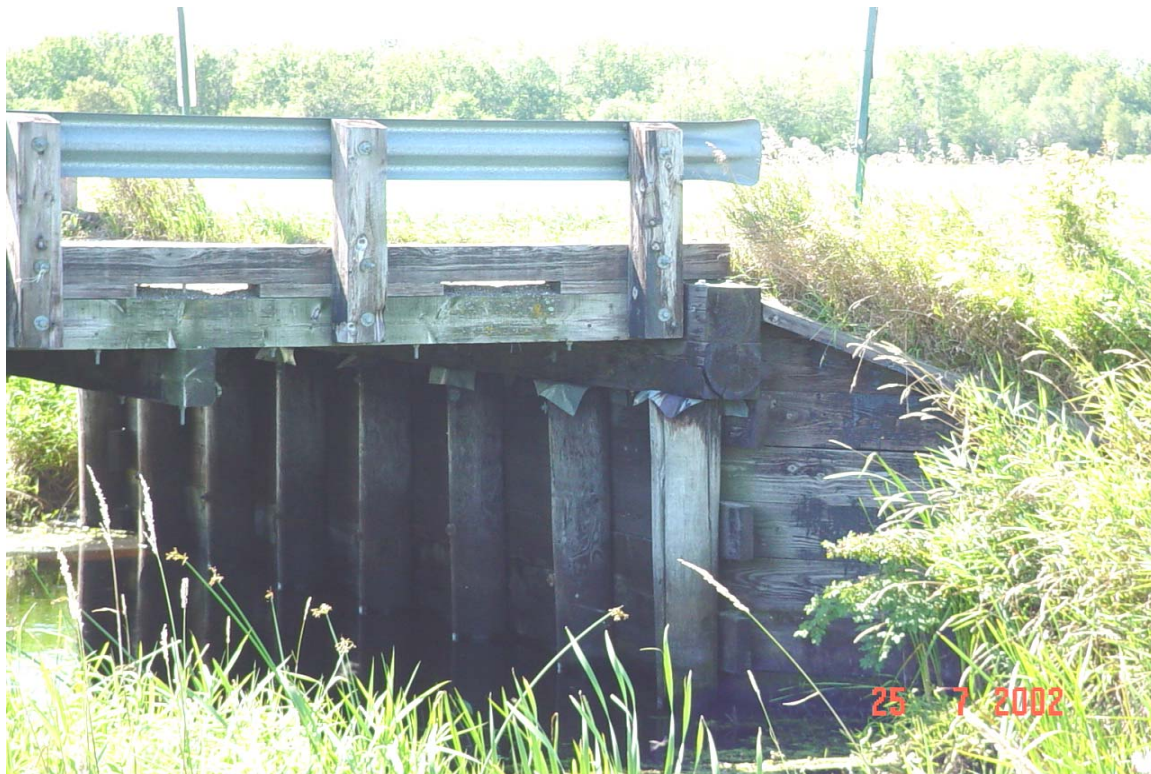
Photograph 3. View of West Abutment, Looking Southwest.

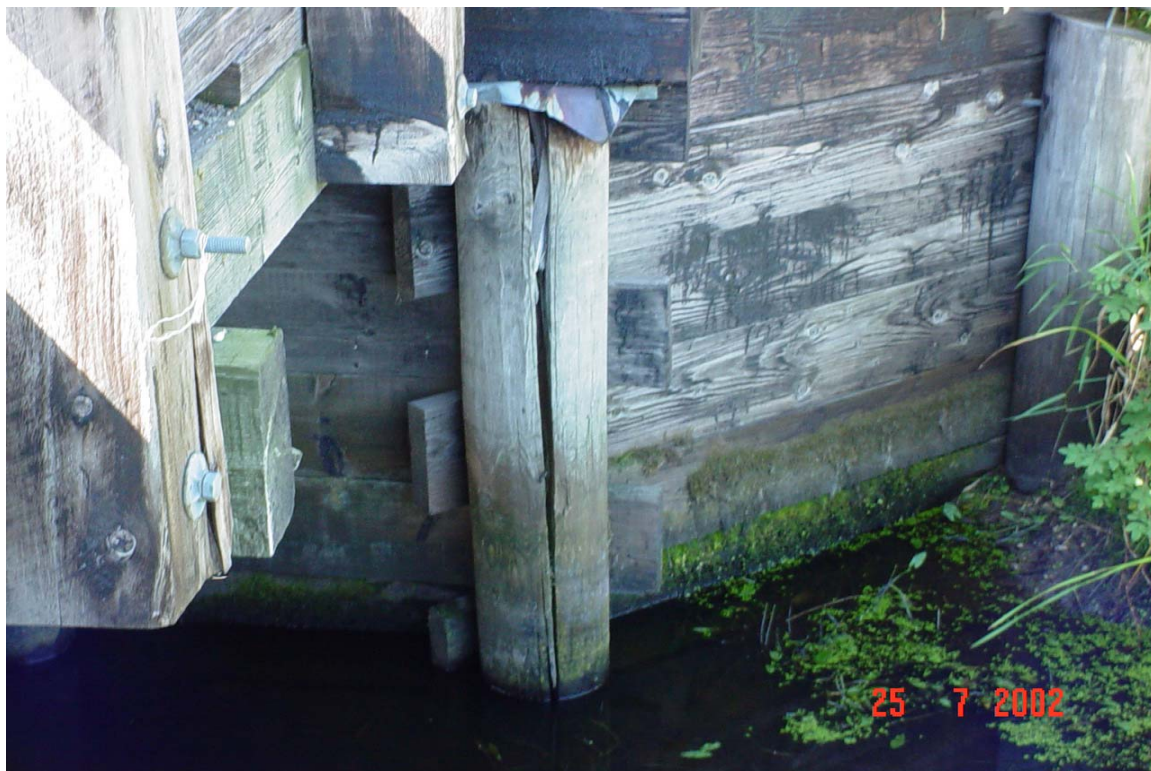
- (A) The upstream timber pile at the West Abutment exhibited cracking with decay in several locations extending through to the middle of the pile.
- (B) The backwall at the East Abutment exhibited 1/4-inch-wide gaps between the planks with minor movement of the planking detected, but with no loss of fill.
- (C) A 1/4-inch-wide split in the wall planking was observed 2 feet above the waterline, extending between the upstream pile of the East Abutment and the 5<sup>th</sup> pile in from the upstream fascia.
- (D) Overall, the timber piles were in good, sound and firm condition with occasional 1/8-inch-wide checking observed.

Photograph 4. View of Split in the Upstream Pile of the West Abutment, Looking West.

- (A) Ideally, the cracked and decayed pile at West Abutment should be replaced to restore full load carrying capacity of the structure. If pile is not replaced or assisted with a helper pile, the existing pile should be monitored during future inspections.
- (B) Reinspect the submerged substructure units at the normal maximum recommended (NBIS) interval of five (5) years. Note that the inspection can be accomplished with waders by general inspection personnel during a period of normal water levels.
